## Firmware replacement

## General information

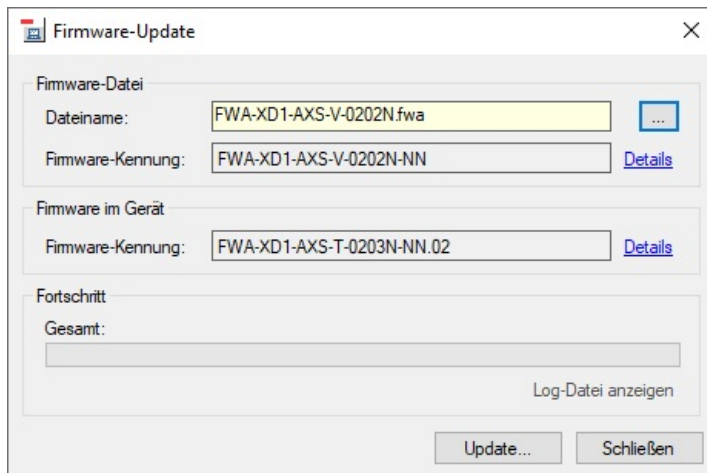
Fig. 96: "Firmware update" dialog in ctrlX DRIVE Engineering

- Select new firmware (\*.fwa file) in the upper part of the dialog and start the firmware replacement via the “Update” button.  
⇒The firmware is downloaded automatically. All required firmware components are loaded to the device.

- After the firmware has been replaced, close the “Firmware update” window.
3. Restart the device.  
At the end of the firmware replacement, ctrlX DRIVE Engineering automatically provides the option to restart the drive via the reboot command S-0-1350 (/redirect/patternMatch?code=S-0-1350&redirectOrigin=ID1675801\_483208643). Optionally, the device can be reset via a control voltage reset.
